Photogrammetric, Satellite-Based Survey of Toluca Airport and Its Surroundings

Final Quality Control Visit Report

Photogrammetric Survey of Toluca Airport and its Surroundings:

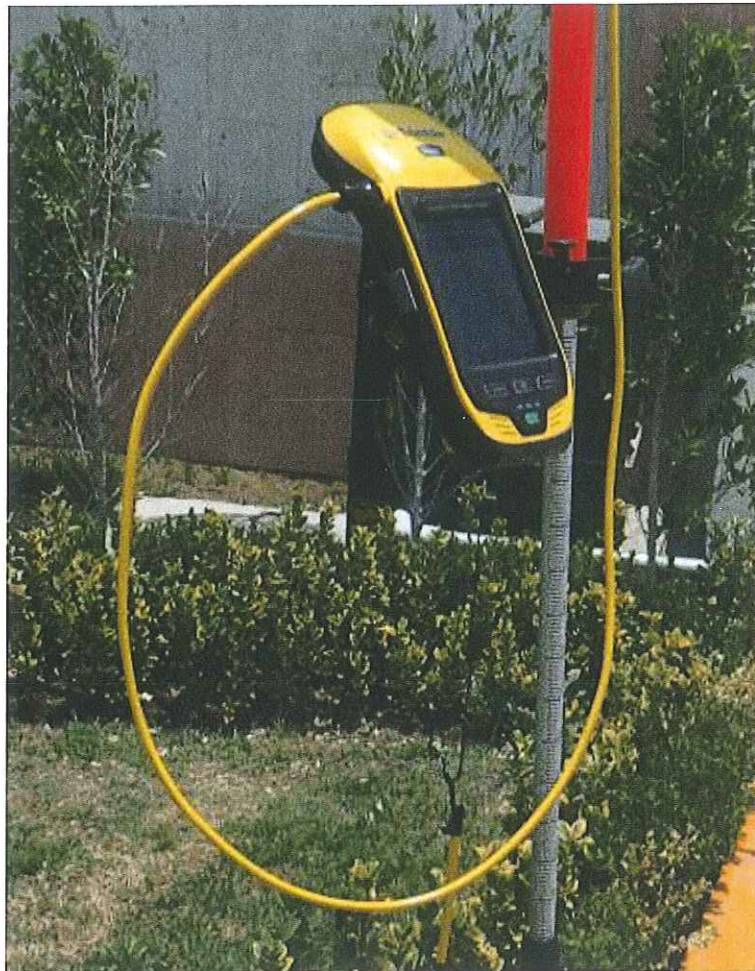
Figure 1 – A Trimble GeoXT Explorer 6000 GPS used to Collect Field Measurements during the Final QC Visit

The Trimble GeoXT Explorer 6000 is a high performance GPS receiver with an on-board computer loaded with ArcGIS Mobile Geographic Information System (GIS) support software (see Figure 1). An external antenna, resistant to signal interference and multipath was used to obtain a higher yield of GPS satellite positions and to improve performance and accuracy. The antenna was connected to the GPS on top of a mounting pole to improve satellite visibility. The

GPS collects GCPs and other field data measurements in X, Y, Z, latitude, longitude and height above Ellipsoid.

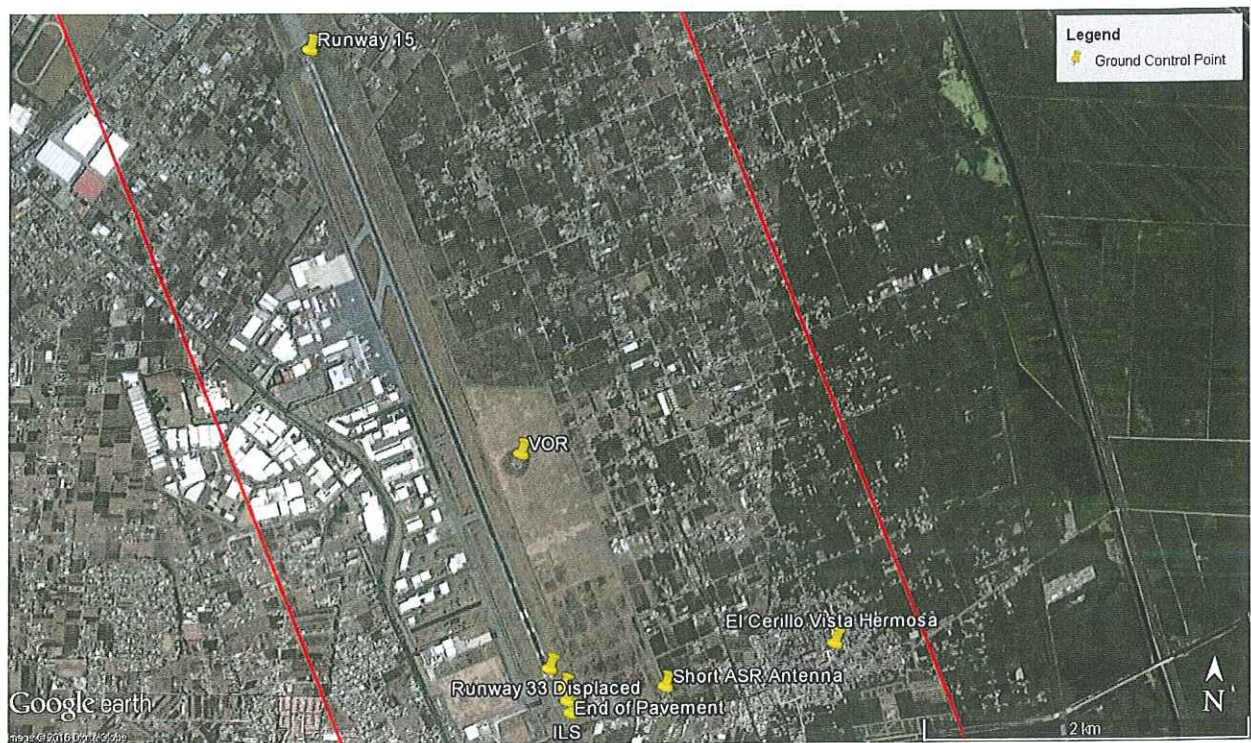
Figure 4 – Location of GCPs Collected During the Final QC Visit

Eight (8) new GCPs were collected during the Final QC Visit. The GCPs can be sub-classed as three threshold points, the ILS Localizer Array center location, the ASR antenna, the VOR and the top of El Cerrillo; all the points, except the latter, were located within the fence at the Toluca Airport (see Figure 4).

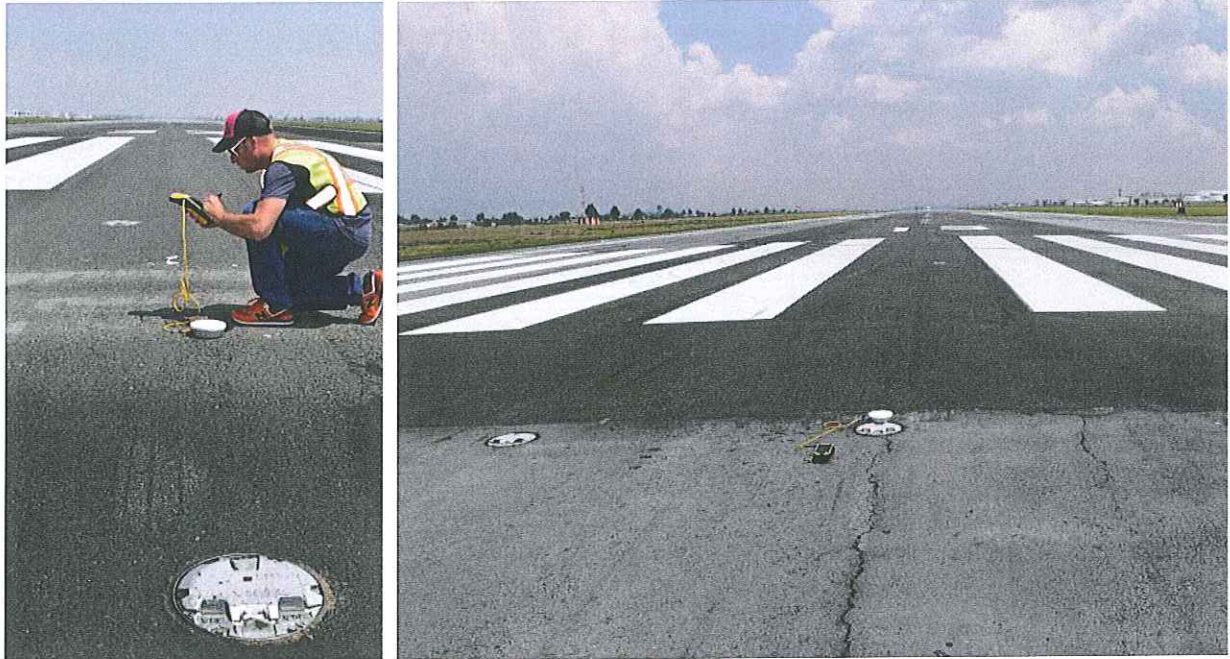
Figure 5 – Reference Photographs Taken of GCP Locations

The GCP locations were measured using a high-precision GPS with an antenna, as described in Section 2.2. Photographs were taken of each location for reference (see Figure 5). Full descriptions and coordinate information for each GCP is provided in Appendix A.

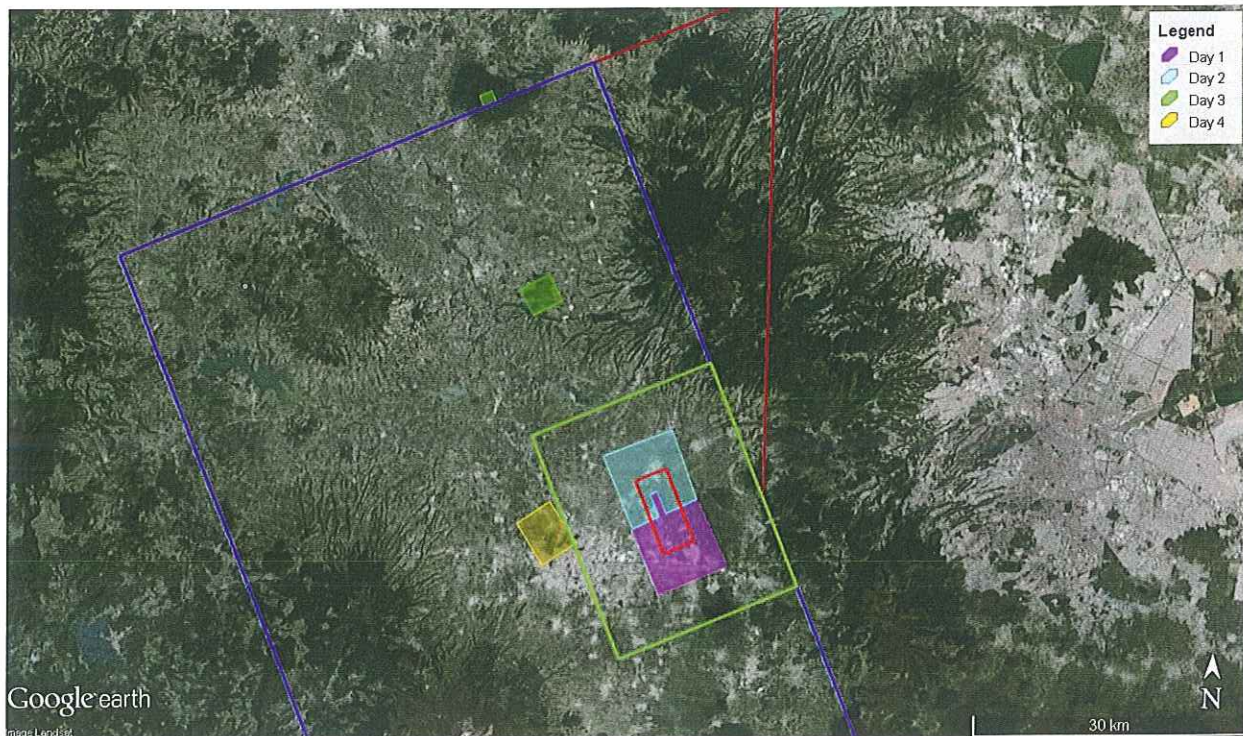
Figure 8 – Critical Aeronautical Areas to Visit during Final QC Visit

Fieldwork Areas for the Team were outlined in the Final QC Trip Plan. In order to systematically collect data and measurements throughout all project areas, MDA divided the entire region into four Fieldwork Areas, as shown in Figure 8 below. It was understood that while these Fieldwork Areas were planned, the Team had flexibility while conducting the Final QC Visit to switch days or combine some areas depending on local conditions. As mentioned above, these four daily Fieldwork Areas were completed in three days.

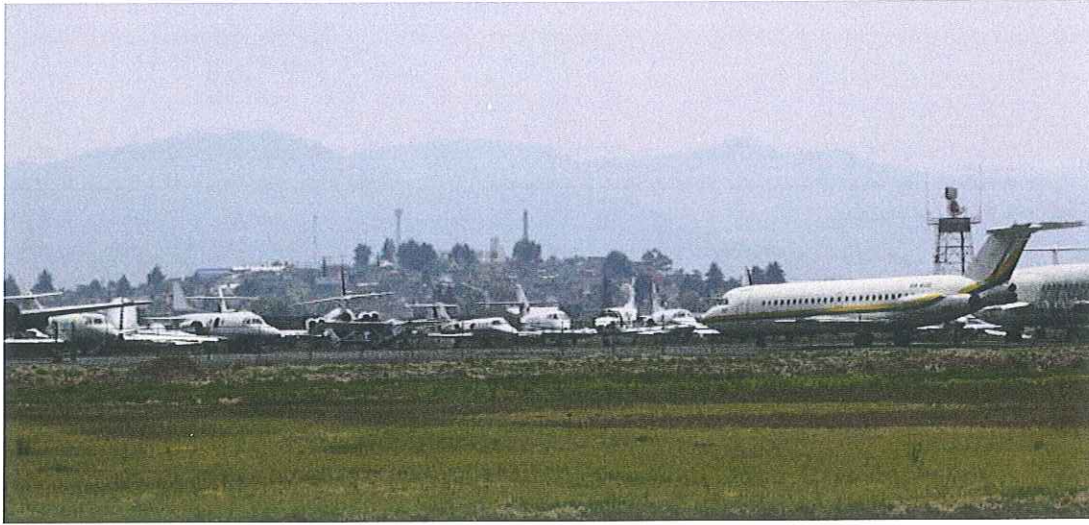
After the meeting, the Team proceeded in the ASA van south to Toluca and started collecting data at Toluca Airport. The representative from the Toluca Airport, Ing. Jesus Soriano, was helpful in trying to clarify numerous questions about the location of items on the airport. The Team was on the airport for approximately four hours. Once all of the measurements were completed at the airport, the Team drove to El Cerrillo, a town located to the east, southeast of Runway 33. The town is located on a small hill and is visible from the airport; see Figure 9 which was taken from the threshold of Runway 33 and Figure 10 taken at El Cerrillo. A total of eight (8) GCPs were collected on 10 May (refer to Appendix A for details).

Figure 9 – Antennas on El Cerrillo as Visible from Runway 33

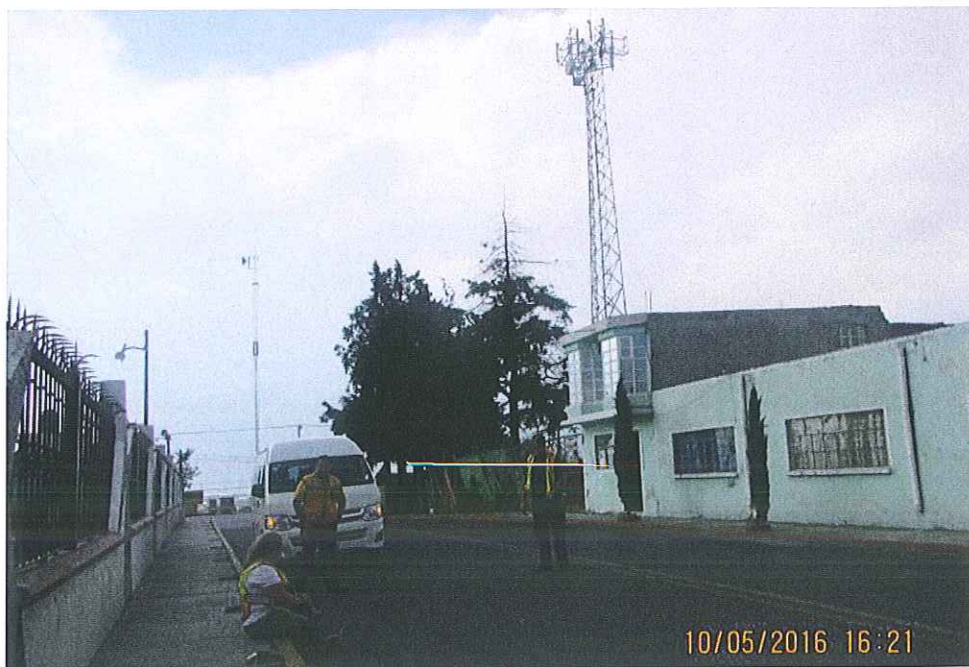
Figure 10 – Antennas Measured on El Cerrillo

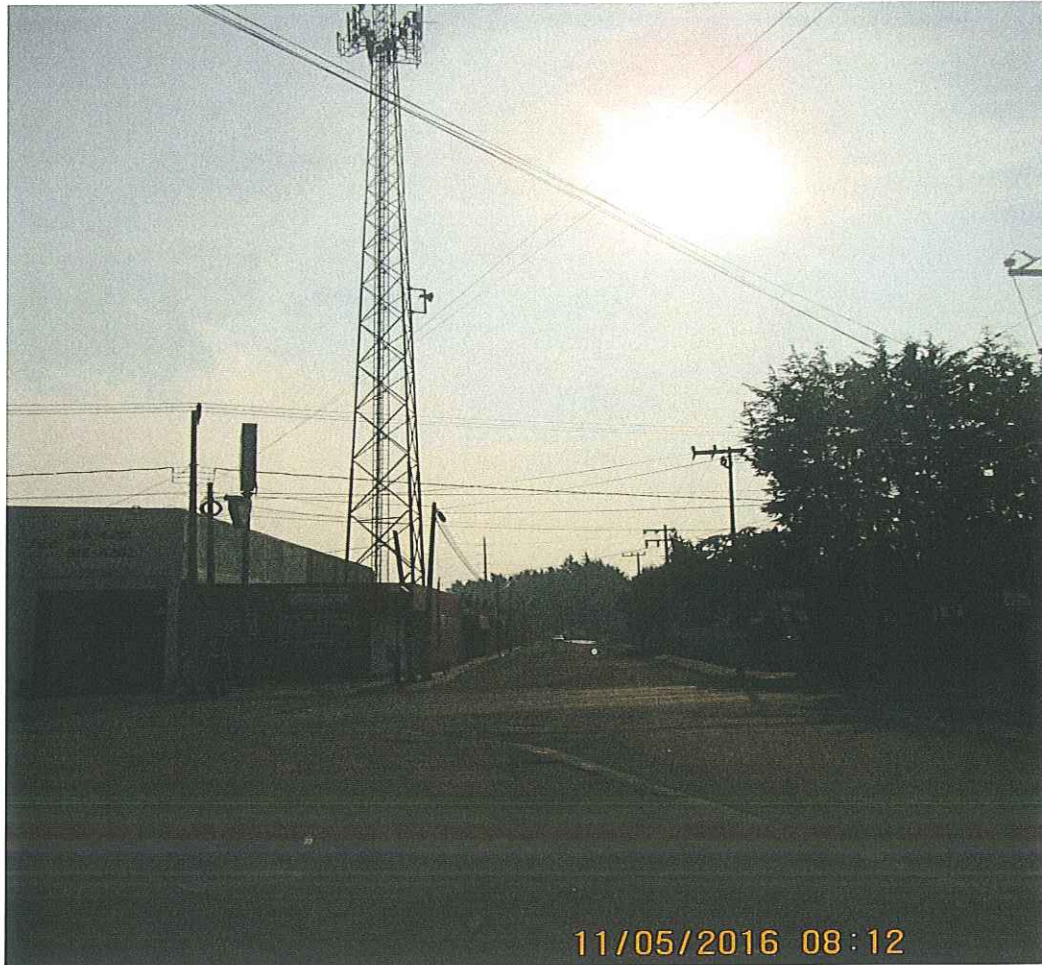
On Wednesday, 11 May, the Team left the hotel in Toluca and headed towards the south of the PSA and into Area A. The Team collected a variety of obstacles directly south of the PSA, including the antenna shown in Figure 11. The Team then went through the City of Toluca looking for tall antennas and buildings that were not already in the database, and drove up the hill directly opposite Cerro la Teresona. The Team observed the antennas on Cerro la

Figure 11 – Antenna South of the PSA in Area A

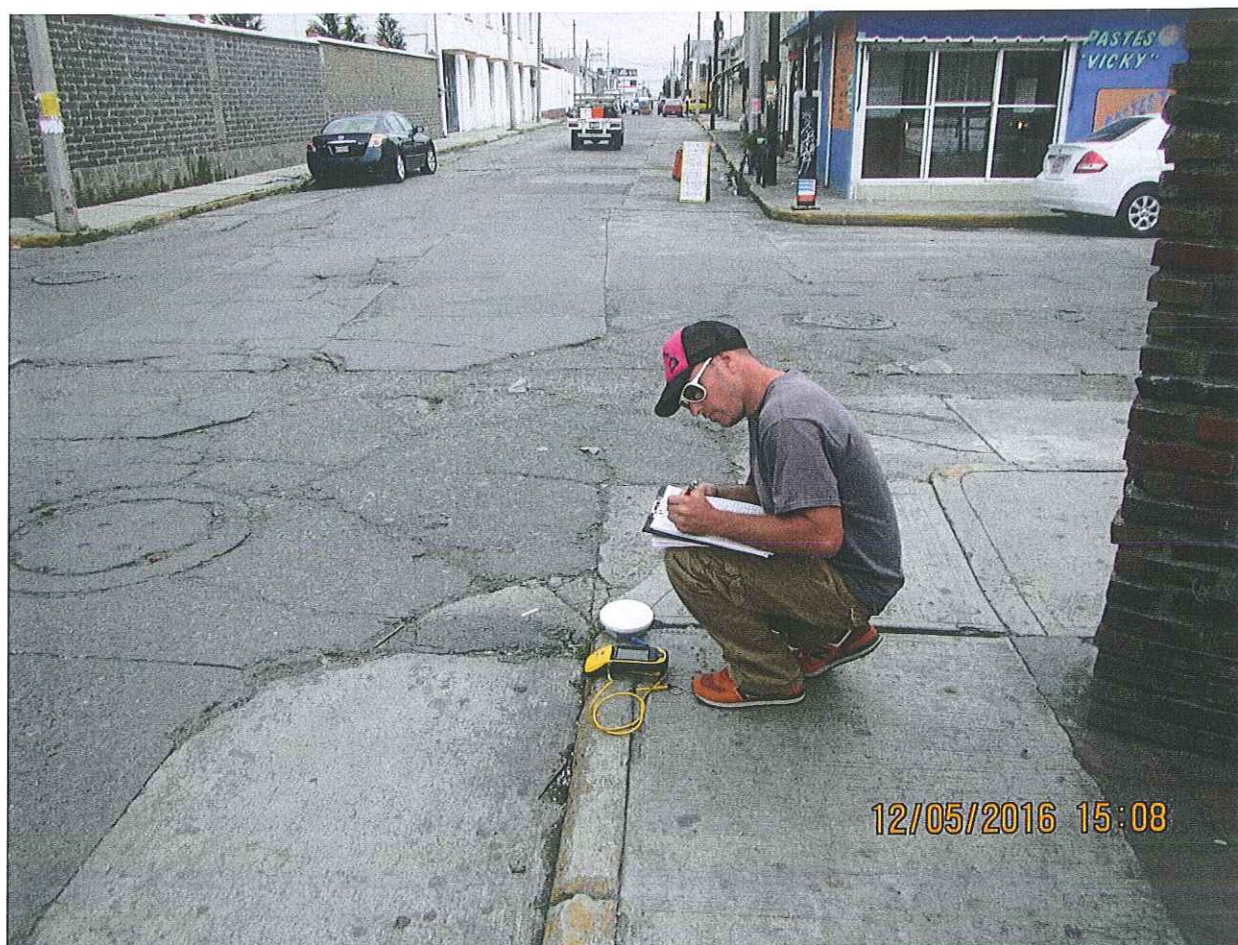
Figure 14 – Mr. McConachie Recording Information from the Trimble GPS used for Validation

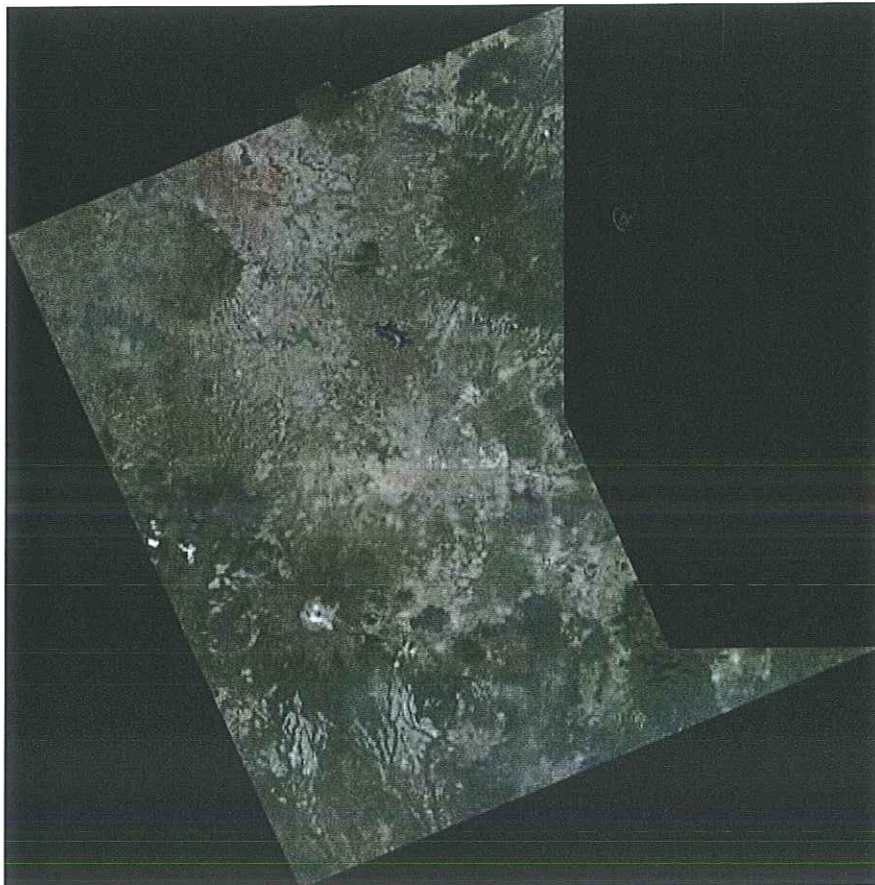
Figure 15 – The Final QuickLook Mosaic for Toluca

WorldView-2 (WV-2), WorldView-3 (WV-3) and Geo-Eye-1 (GE-1) were tasked to acquire the colour imagery over all of the Project Areas. The image resolution is 0.30 m for Area A and will be pan-sharpened for delivery. Area B, the Triangular Areas and the Special Areas will have an image resolution of 0.5 m. Figure 15 provides an illustration (generated from all of the source image QuickLooks) of what the final image mosaic for all Project areas will look like.

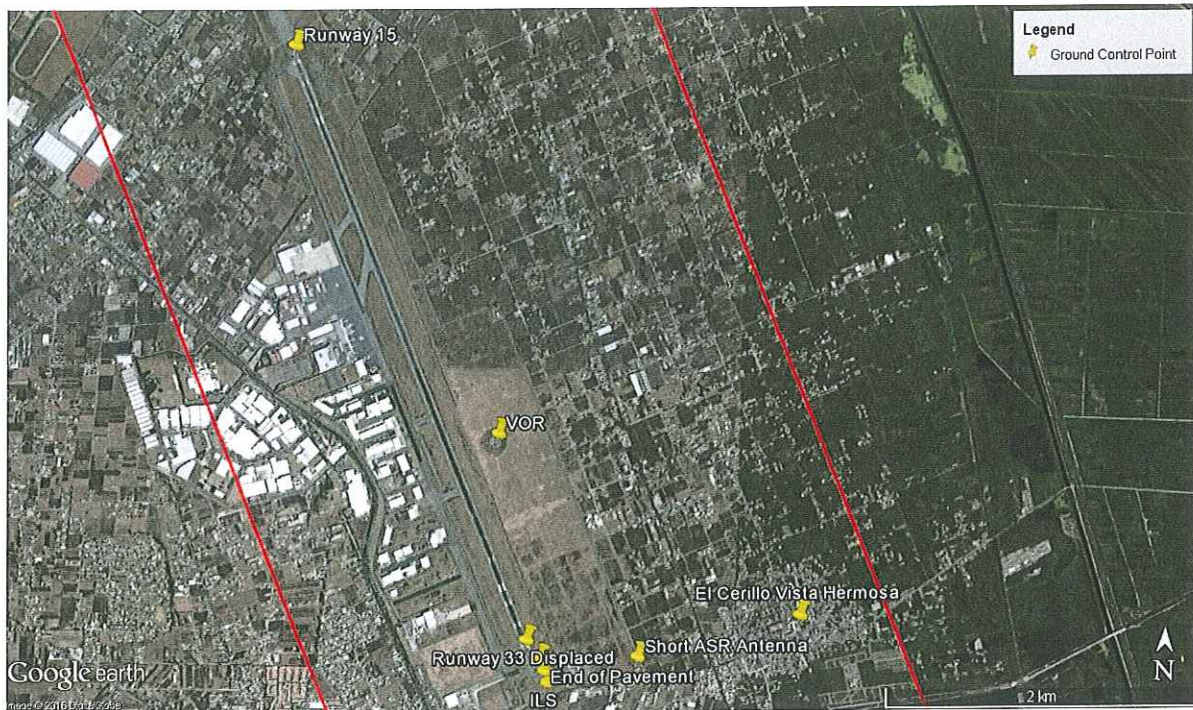
Figure 16 – GCPs Collected during QC Visit

This Appendix contains information on all eight (8) collected GCPs, shown in Figure 16 below. Each GCP is described on a separate page, with the coordinates, date collected and field photographs.

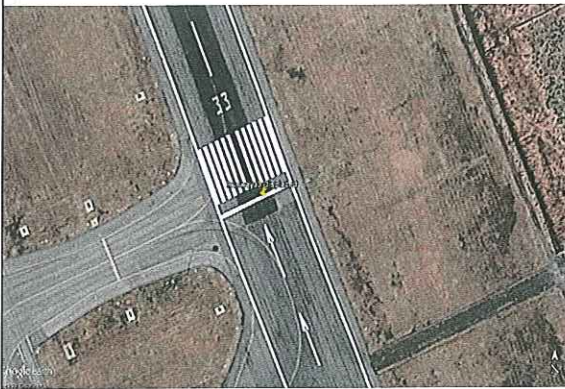
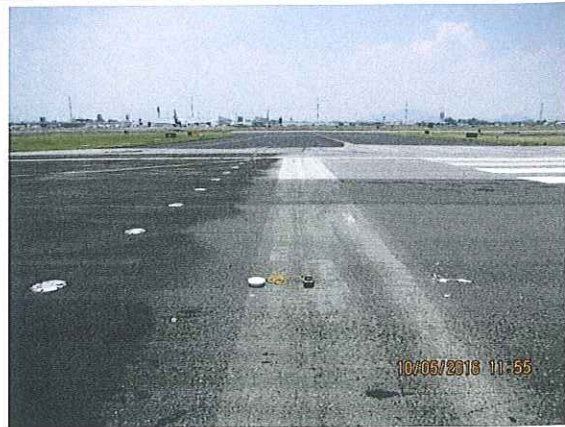
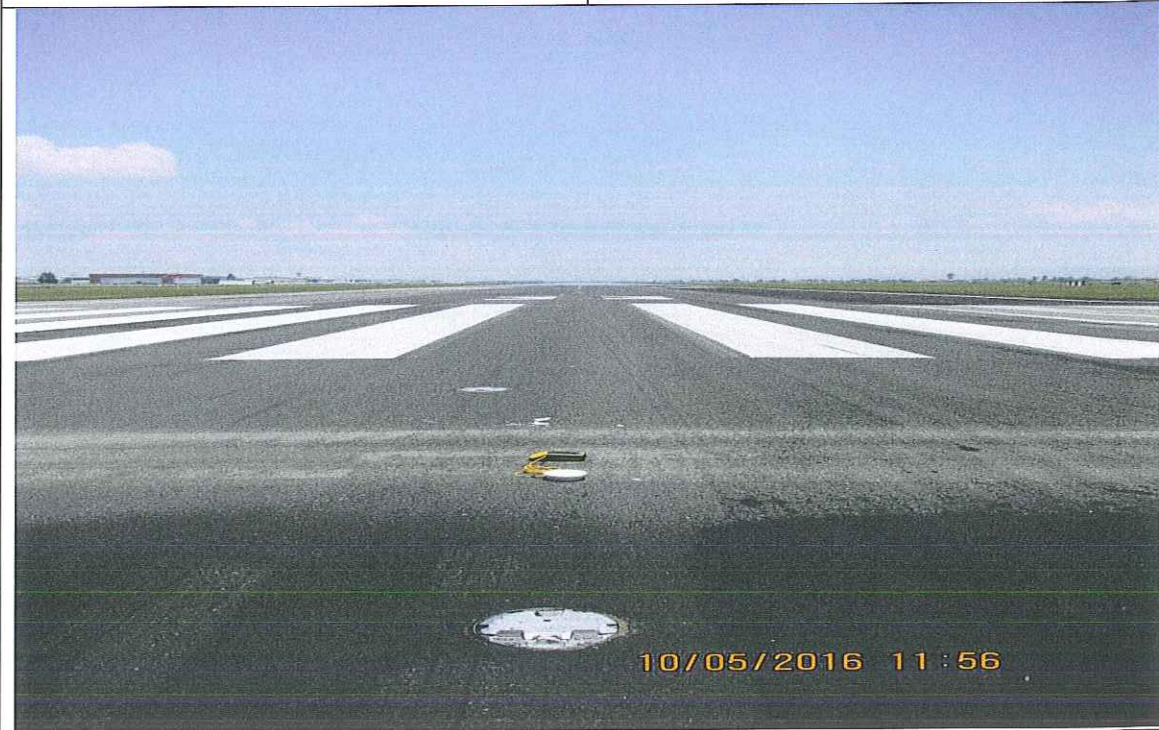
Project: Toluca Area Survey	Country: Mexico	Region: Toluca Area, Mexico
Control Point ID: Runway 33 Displaced Threshold	Collection Date: 10 May 2016	Instrument: Trimble GeoExplorer
Latitude: 19° 19' 15.58" N	Longitude: 099° 33' 31.50" W	Height (above sea level): 2579.142 m
Project Area: PSA		Datum: World Geodetic System 1984 (WGS84) / Earth Gravitational Model 1996 (EGM96)

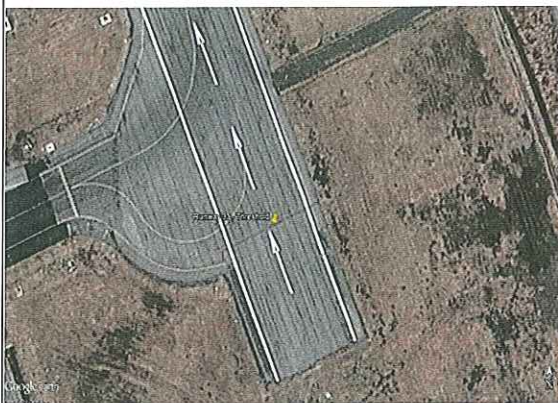
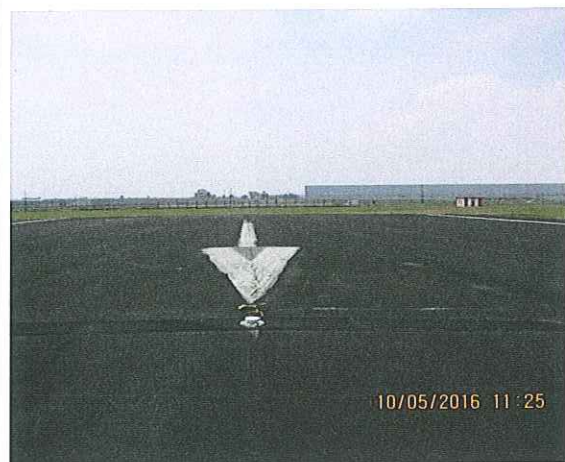
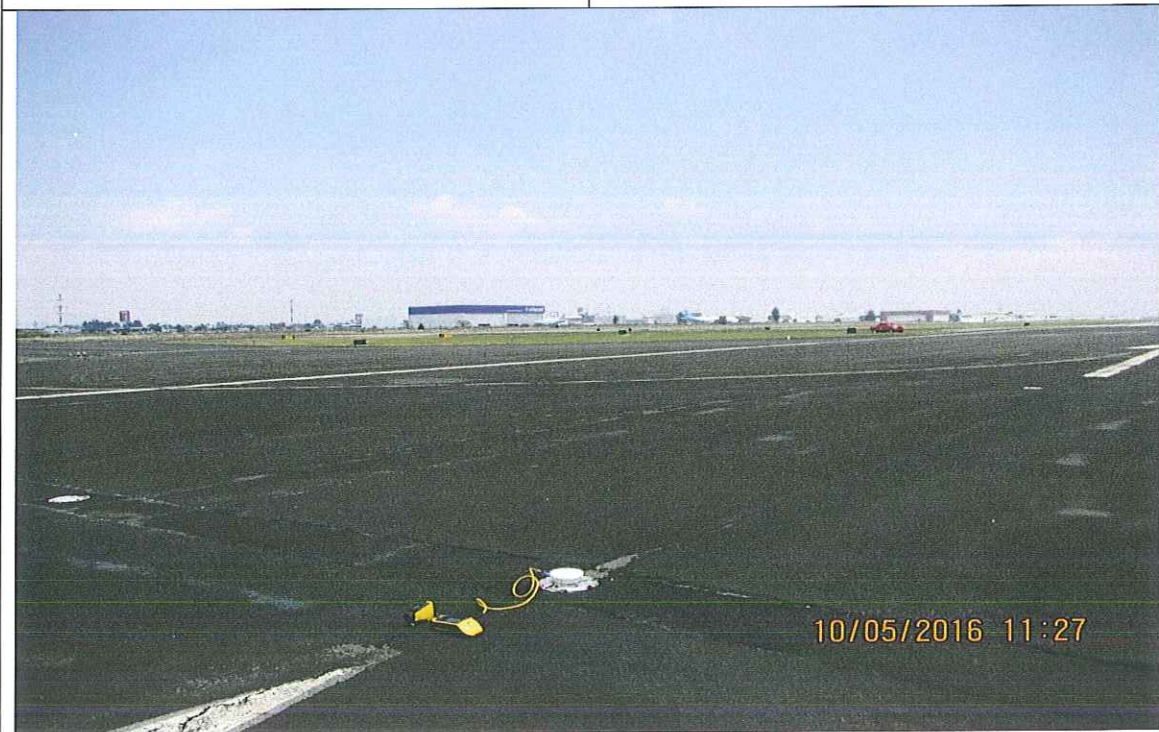
Project: Toluca Area Survey	Country: Mexico	Region: Toluca Area, Mexico
Control Point ID: Runway 33 Threshold	Collection Date: 10 May 2016	Instrument: Trimble GeoExplorer
Latitude: 19° 19' 10.78" N	Longitude: 099° 33' 29.33" W	Height (above sea level): 2578.920 m
Project Area: PSA		Datum: WGS84/EGM96

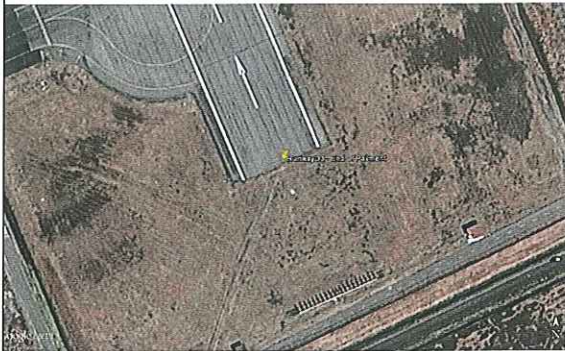
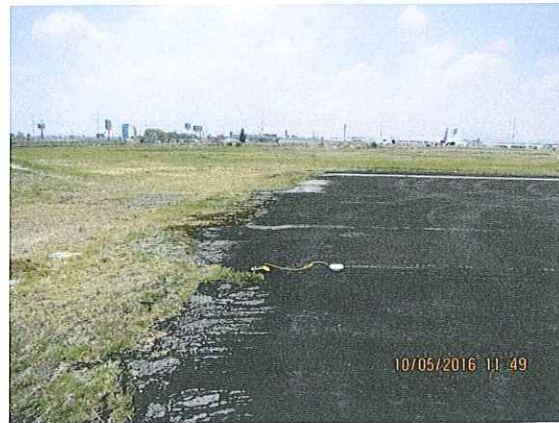
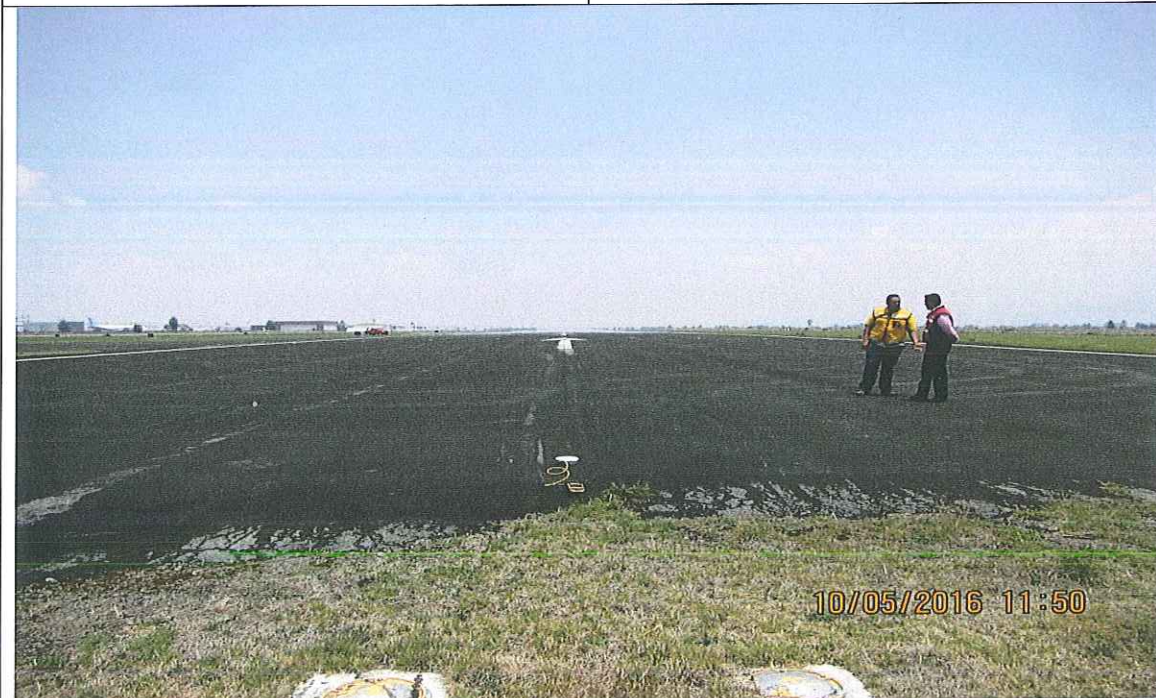
Project: Toluca Area Survey	Country: Mexico	Region: Toluca Area, Mexico
Control Point ID: Runway 33 End of Pavement	Collection Date: 10 May 2016	Instrument: Trimble GeoExplorer
Latitude: 19° 19' 08.90" N	Longitude: 099° 33' 28.48" W	Height (above sea level): 2578.43 m
Project Area: PSA		Datum: WGS84/EGM96

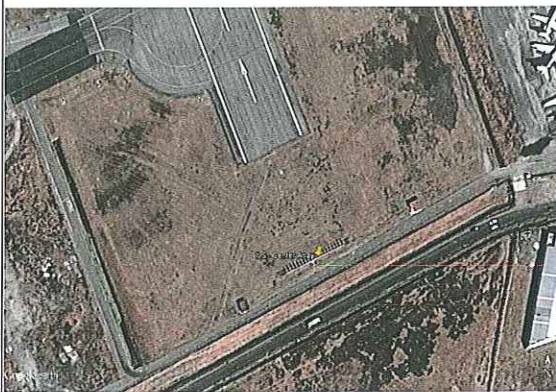
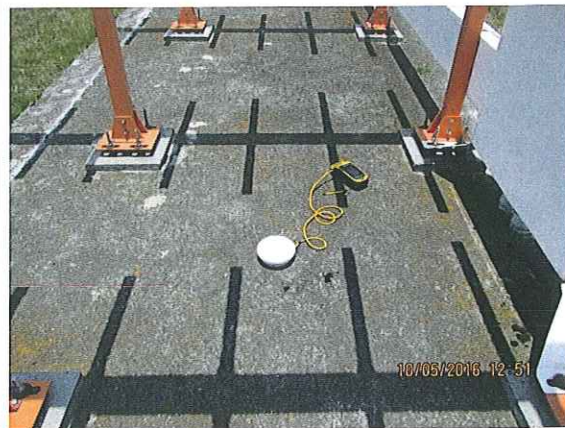
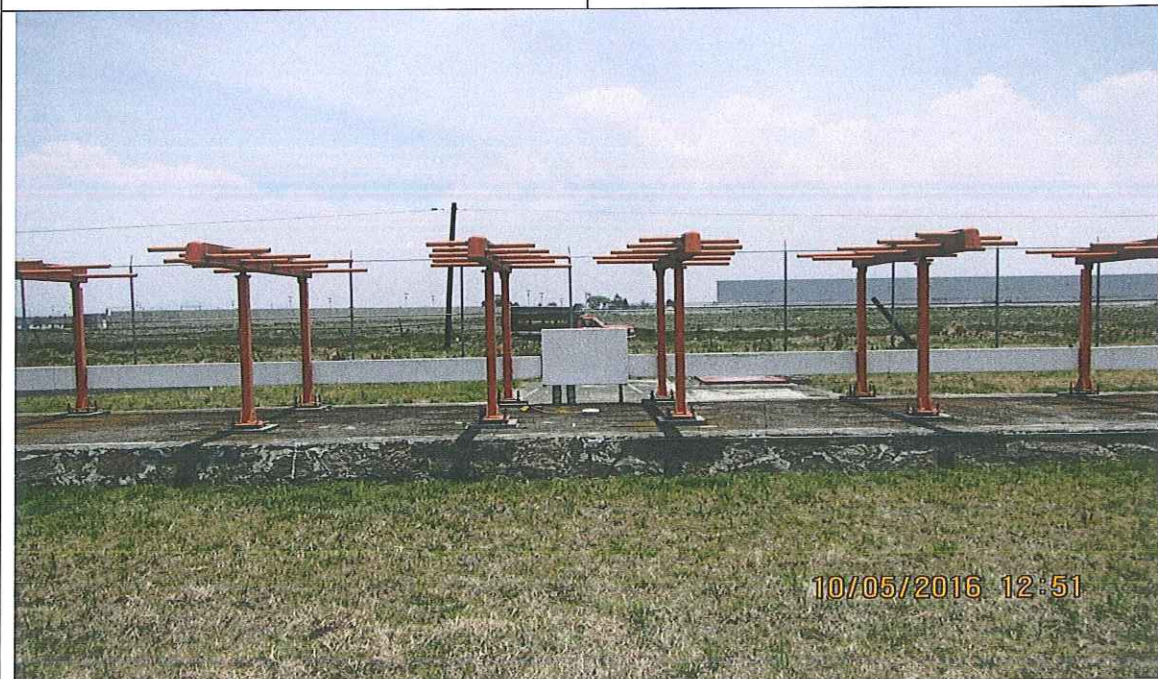
Project: Toluca Area Survey	Country: Mexico	Region: Toluca Area, Mexico
Control Point ID: ILS Localizer Center Array	Collection Date: 10 May 2016	Instrument: Trimble GeoExplorer
Latitude: 19° 19' 06.60" N	Longitude: 099° 33' 27.44" W	Height (above sea level): 2578.218 m
Project Area: PSA		Datum: WGS84/EGM96

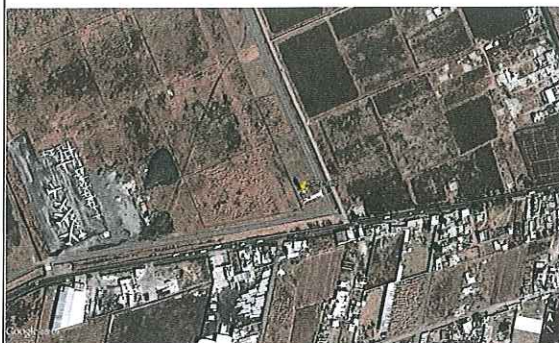
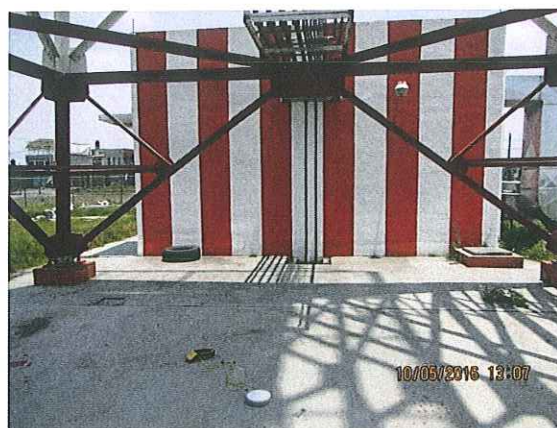
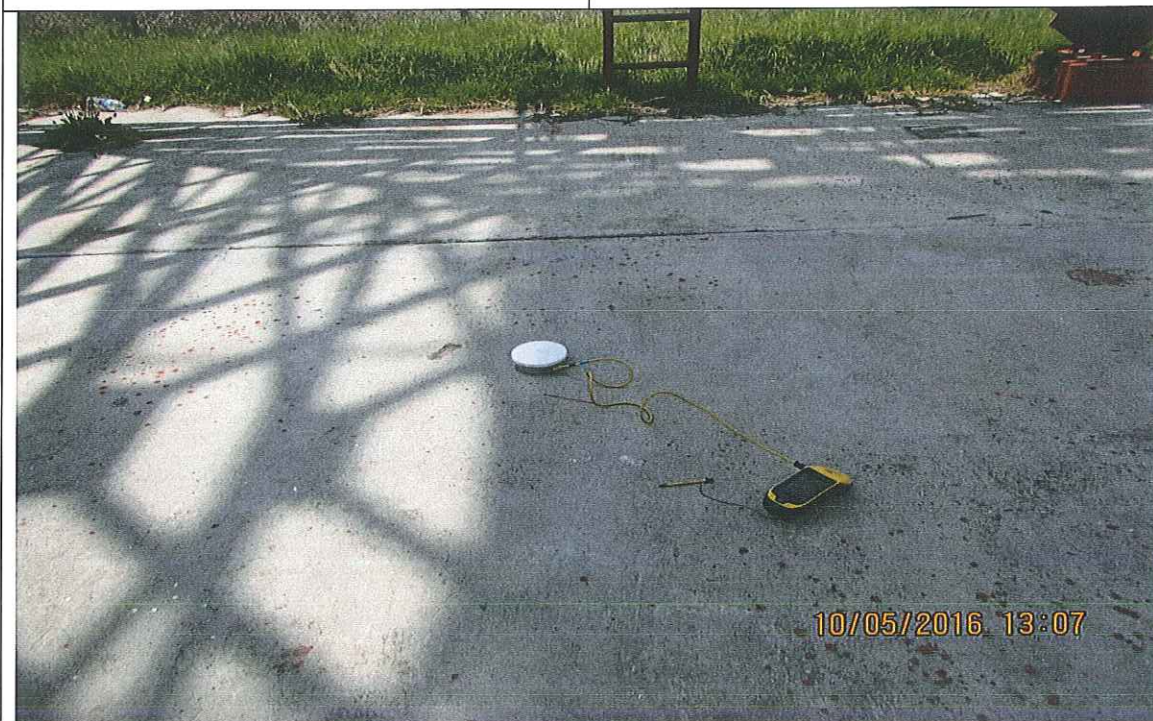
Project: Toluca Area Survey	Country: Mexico	Region: Toluca Area, Mexico
Control Point ID: ASR	Collection Date: 10 May 2016	Instrument: Trimble GeoExplorer
Latitude: 19° 19' 12.15" N	Longitude: 099° 33' 07.69" W	Height (above sea level): 2577.762 m
Project Area: PSA		Datum: WGS84/EGM96

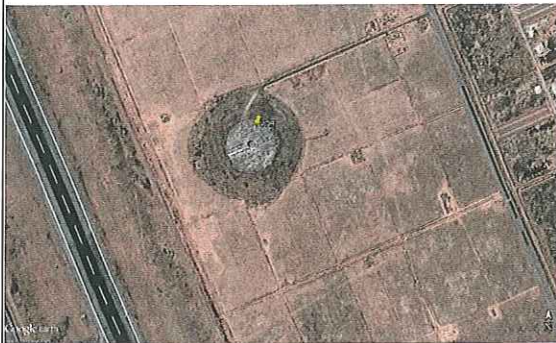
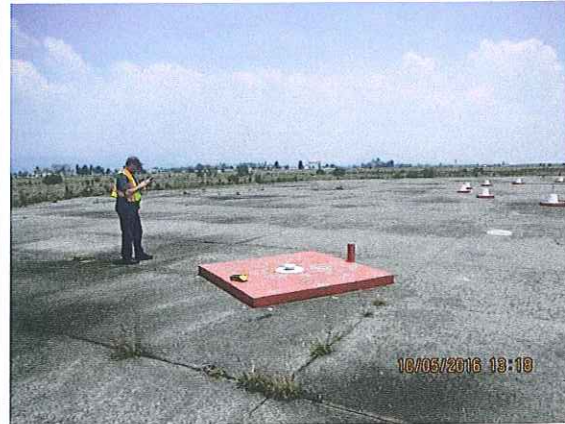
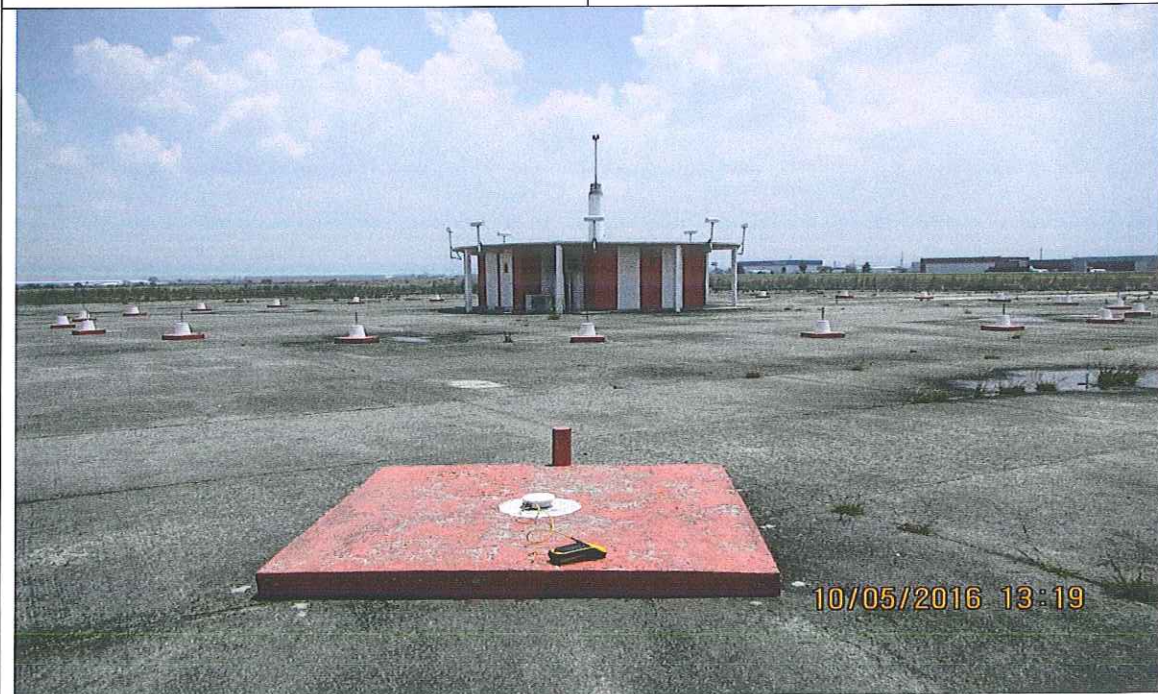
Project: Toluca Area Survey	Country: Mexico	Region: Toluca Area, Mexico
Control Point ID: VOR	Collection Date: 10 May 2016	Instrument: Trimble GeoExplorer
Latitude: 19° 19' 59.26" N	Longitude: 099° 33' 39.53" W	Height (above sea level): 2578.419 m
Project Area: PSA		Datum: WGS84/EGM96

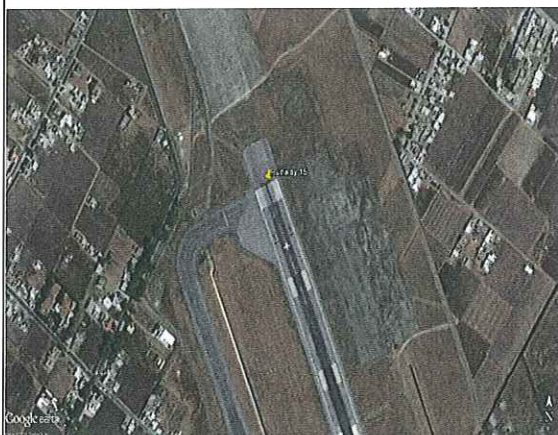
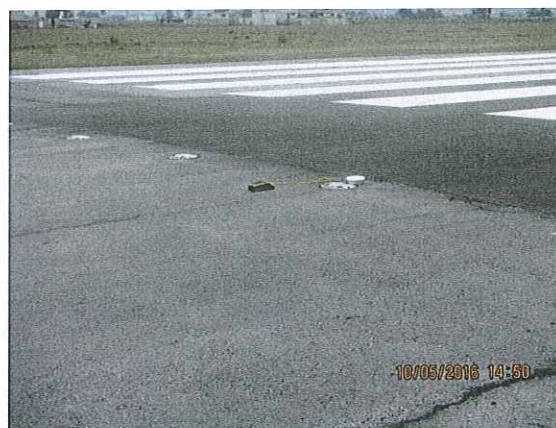
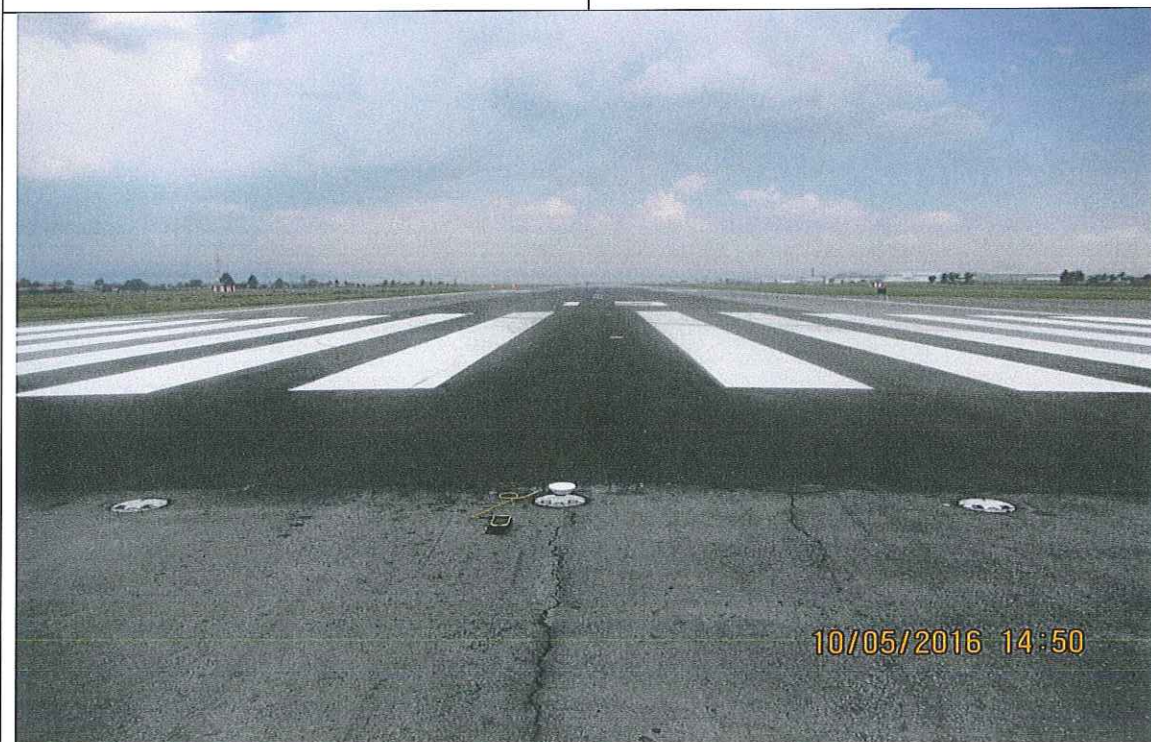
Project: Toluca Area Survey	Country: Mexico	Region: Toluca Area, Mexico
Control Point ID: Runway 15	Collection Date: 10 May 2016	Instrument: Trimble GeoExplorer
Latitude: 19° 21' 16.25" N	Longitude: 099° 34' 26.14" W	Height (above sea level): 2578.744 m
Project Area: Area PSA		Datum: WGS84/EGM96

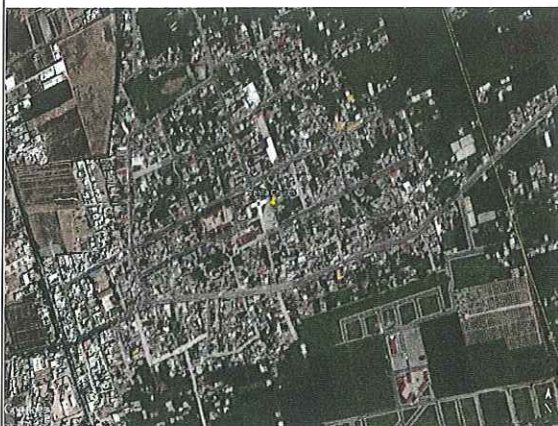
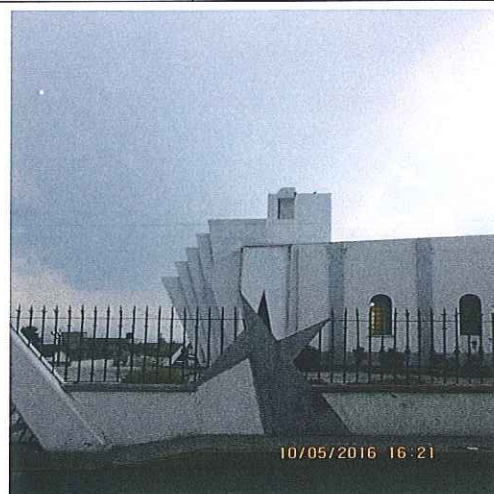
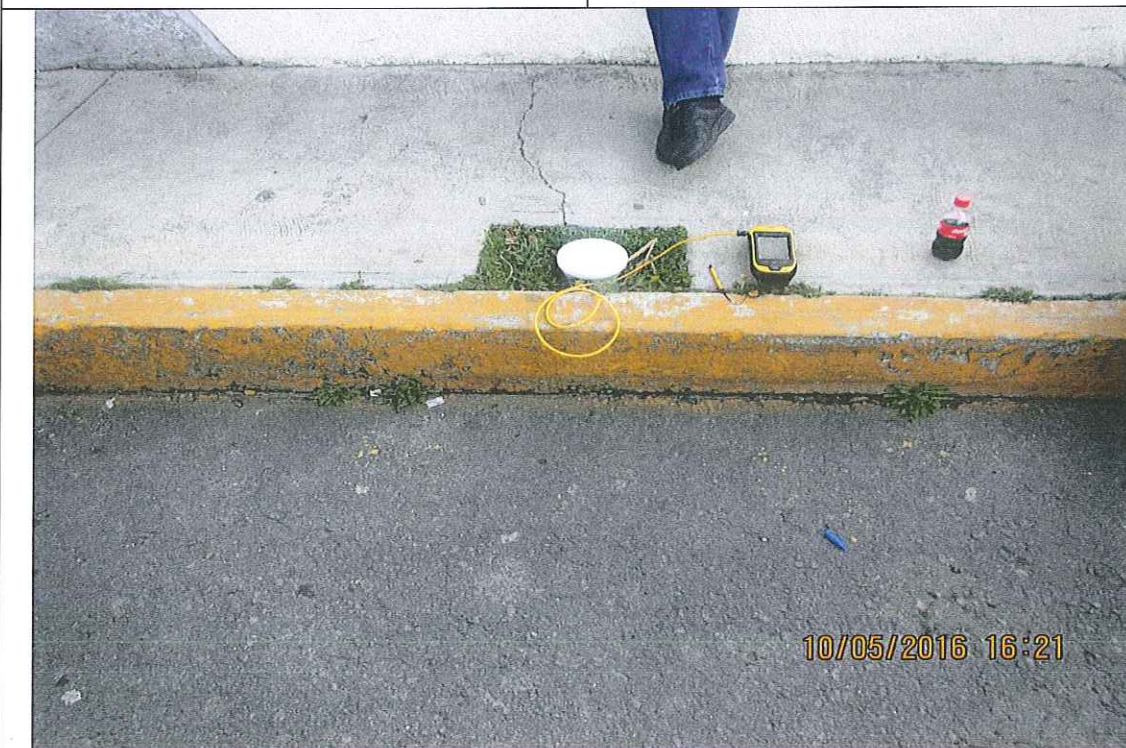
Project: Toluca Area Survey	Country: Mexico	Region: Toluca Area, Mexico
Control Point ID: El Cerrillo Church	Collection Date: 10 May 2016	Instrument: Trimble GeoExplorer
Latitude: 19° 19' 21.99" N	Longitude: 099° 32' 31.52" W	Height (above sea level): 2600.911 m
Project Area: Area PSA		Datum: WGS84/EGM96
