**Center for Advanced
Aviation System Development**

Photogrammetric, Satellite-Based Survey of the Texcoco Area and Its Surroundings

Ground Validation Visit Report

September 2014

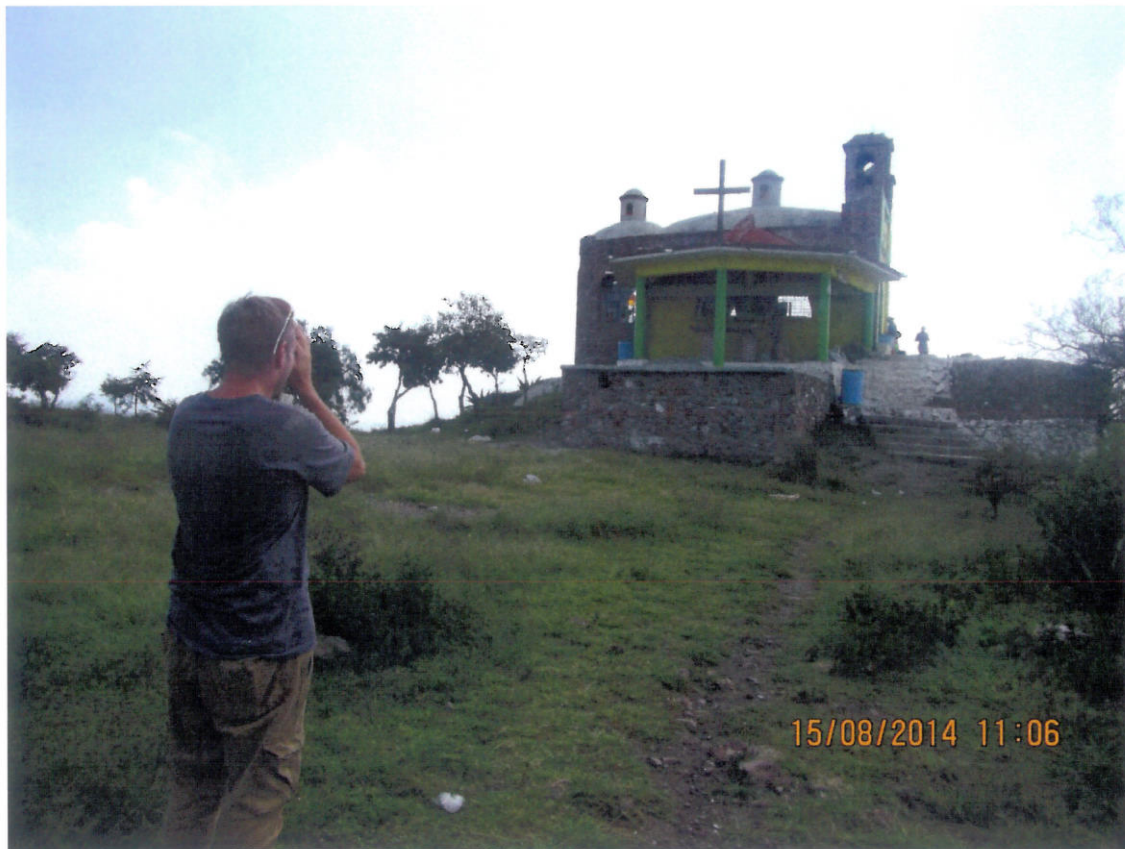
Figure 9 – Mr. McConachie Measuring the Height of a Church on Cerro de Las Promesas (vdb030)

Obstruction data collection within the stereoscopic image area was the primary task for the duration of the Ground Validation Visit. The teams systematically went to each assigned daily area to measure all visible Obstructions using a GPS and a Laser Range Finder (Figure 9). During week two of the Ground Validation Visit, two teams of MDA personnel were in the field collecting data. One team used the ASA van to drive to the easily accessible areas, and the second team used the Oxus Ford F-150 Truck for the difficult areas; both teams had the task of collecting CPs that had been previously selected and to collect Obstructions at all locations. The collection was always conducted by a team of two MDA personnel, with team members alternating between the ASA van and the Ford F-150 truck.

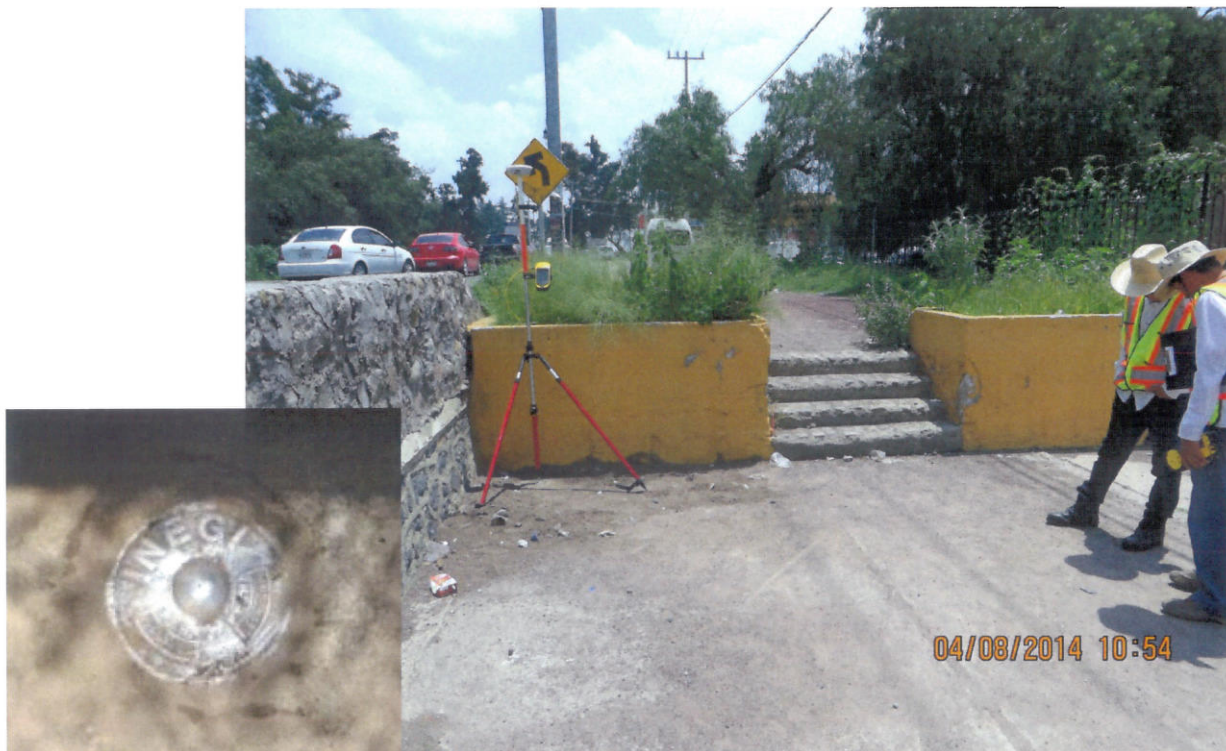
Figure 11 – Collecting and Measuring INEGI Benchmark 793 Located South of Texcoco along Highway 136 (inset shows an actual INEGI marker at this location)

The team then proceeded to drive to each days allotted points and/or areas to collect Obstructions and CPs as per the weekly plan. The team followed public roads in the region, stopping to measure several INEGI Benchmarks (Figure 11) and validation areas.

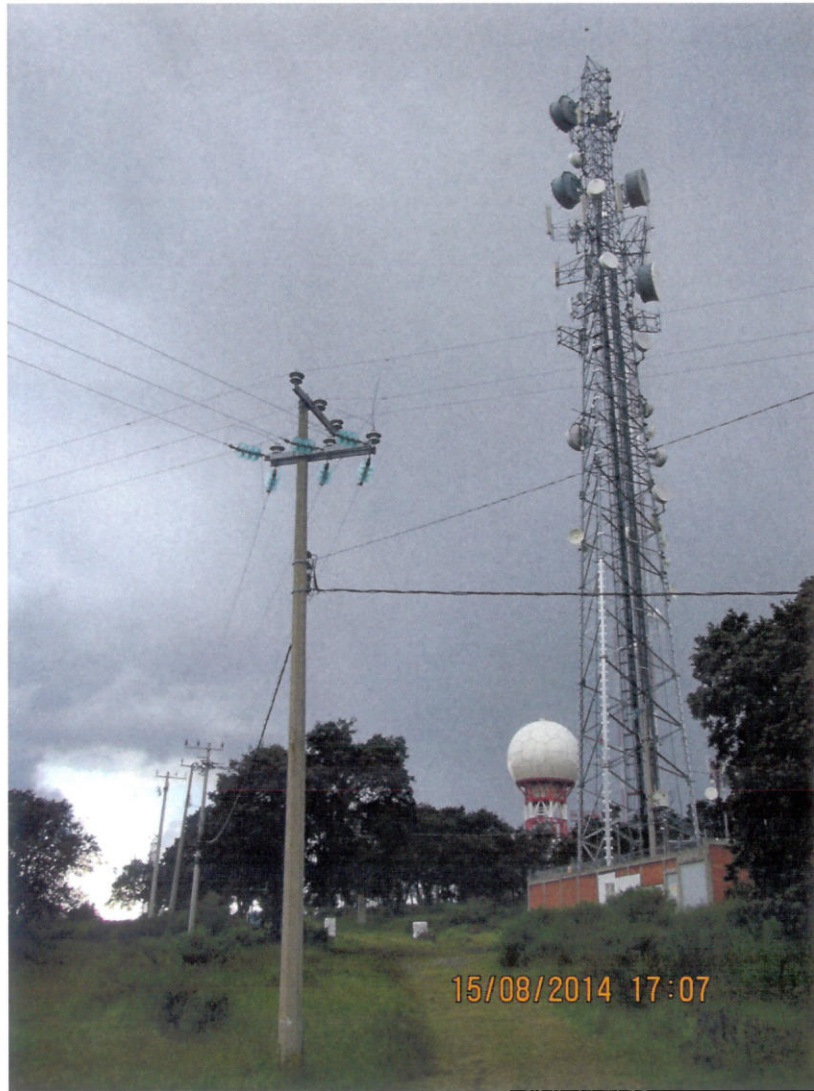
**Figure 16 – Collecting Antenna Heights on Cerro Gordo, Antenna Pictured (vdb097)
Measured to be 65 m AGL**

12 antennas were measured on Cerro Gordo having heights ranging from 21 m to 65 m in height AGL. The tallest of the antennas, and the only one greater than 60 m AGL, is numbered vdb097 and can be seen in Figure 16.

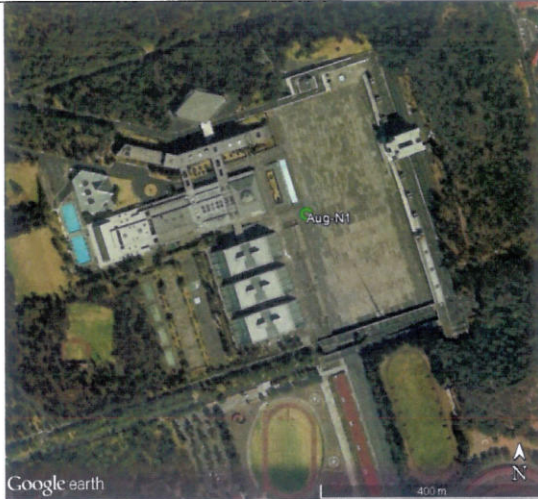
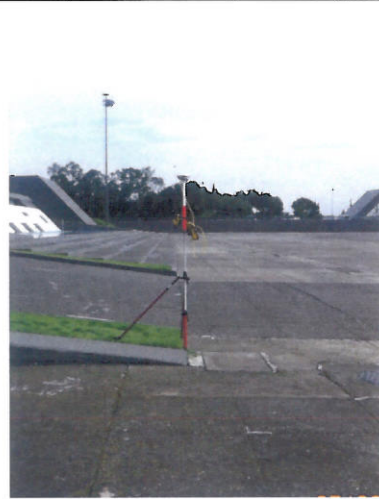
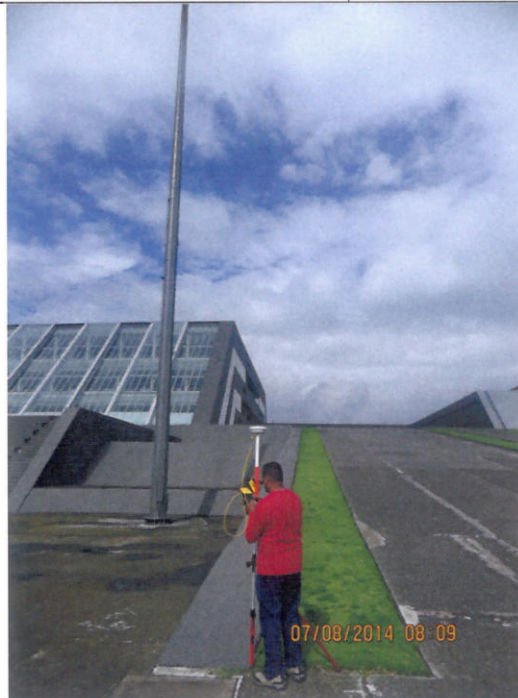
Figure A-2 – Description of CP Aug N1

Project: Texcoco Area Survey	Country: Mexico	Region: Texcoco Area, Mexico
Control Point ID: Aug N1	Collection Date: 7 August 2014	Instrument: Trimble GeoExplorer
Latitude: 19° 15' 32.14"N	Longitude: 99° 08' 59.13" W	Height (MSL): 2336.385 m
Project Area: Heroico Colegio Militar		Datum: World Geodetic System 1984 (WGS84)/ Earth Gravitational Model 1996 (EGM96)

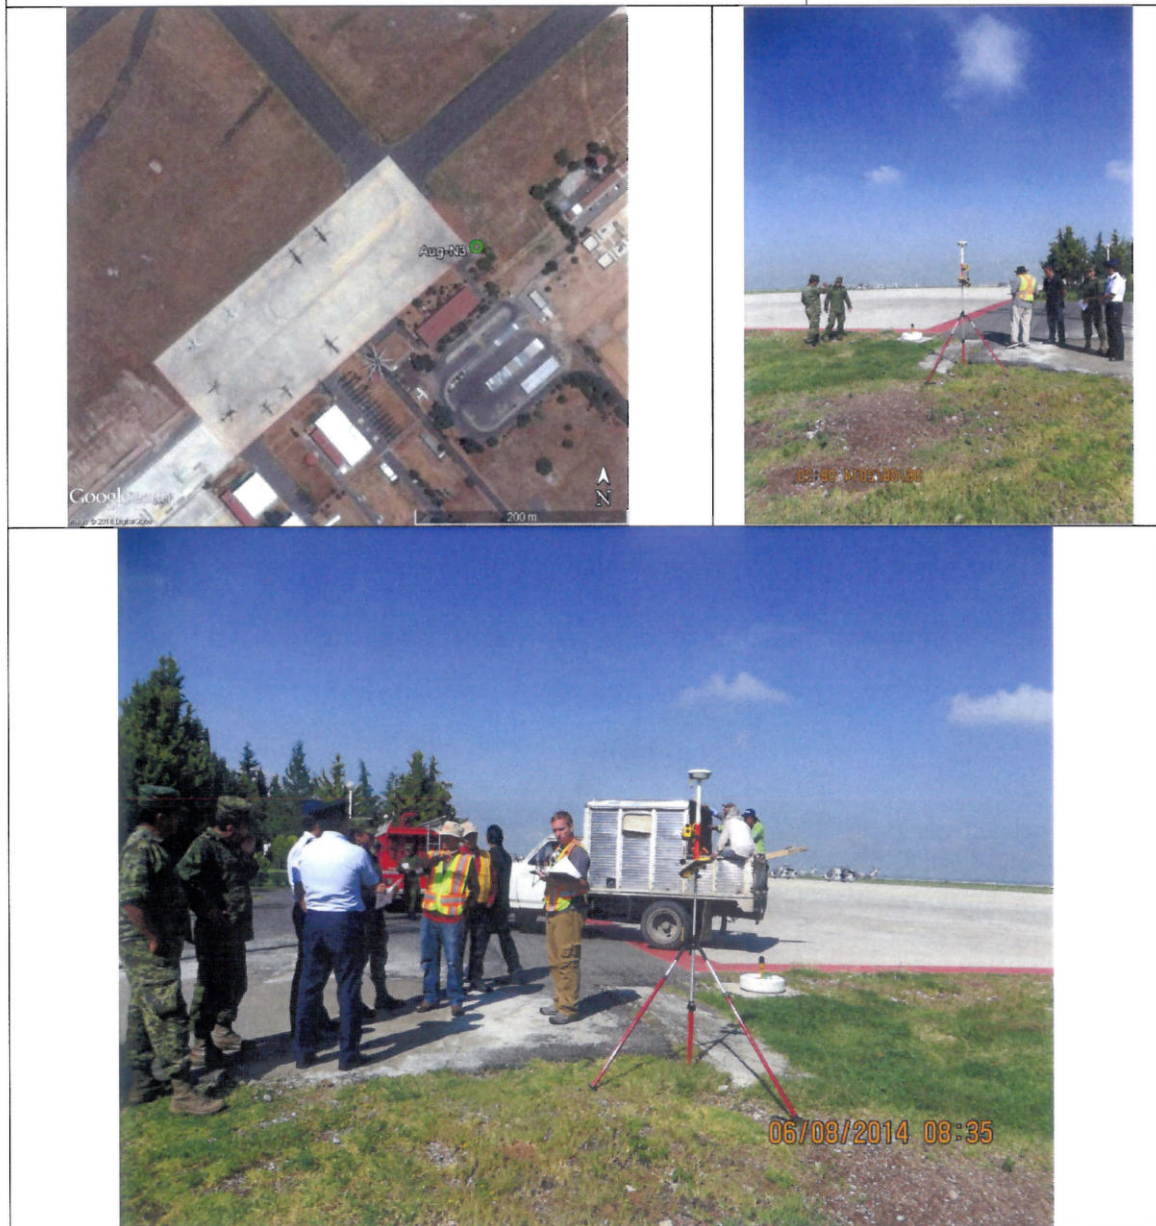
Figure A-3 – Description of CP Aug N2

Project: Texcoco Area Survey	Country: Mexico	Region: Texcoco Area, Mexico
Control Point ID: Aug N2	Collection Date: 6 August 2014	Instrument: Trimble GeoExplorer
Latitude: 19° 45' 02.41" N	Longitude: 99° 00' 48.20" W	Height (MSL): 2242.903 m
Project Area: Santa Lucía Military Base		Datum: WGS84/EGM96

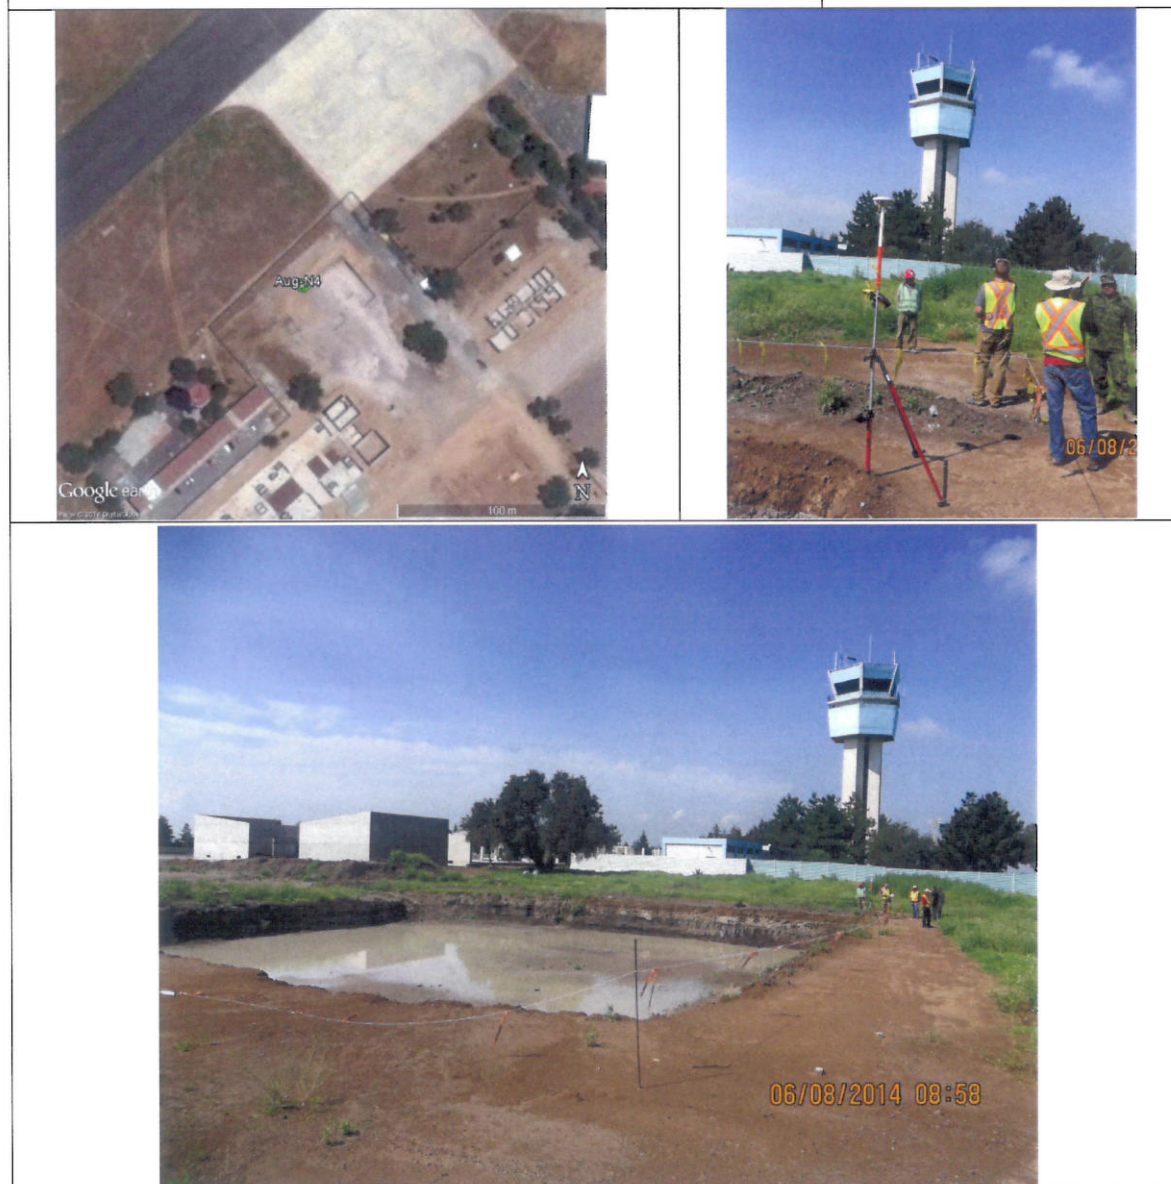
Figure A-5 – Description of CP Aug N4

Project: Texcoco Area Survey	Country: Mexico	Region: Texcoco Area, Mexico
Control Point ID: Aug N4	Collection Date: 6 August 2014	Instrument: Trimble GeoExplorer
Latitude: 19° 45' 06.69" N	Longitude: 99° 00' 42.47" W	Height (MSL): 2242.308 m
Project Area: Santa Lucía Military Base, Site of New Control Tower being Built		Datum: WGS84/EGM96

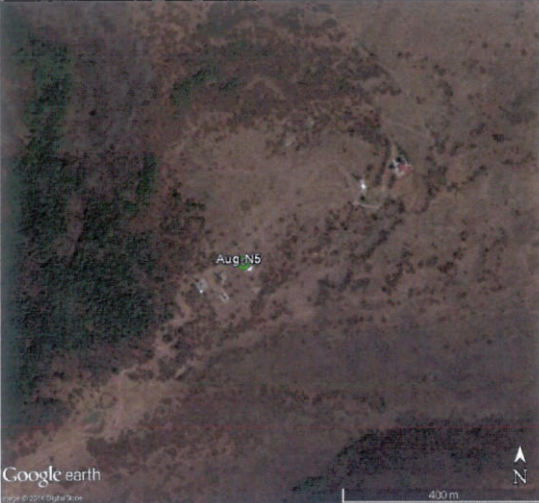
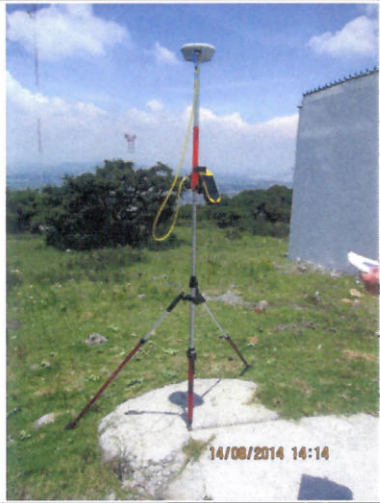
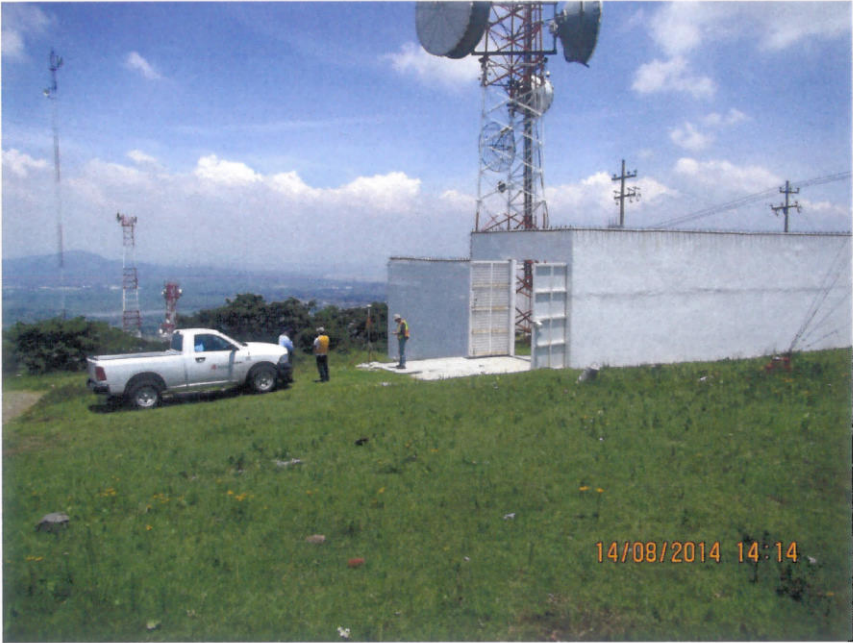
Figure A-6 – Description of CP Aug N5

Project: Texcoco Area Survey	Country: Mexico	Region: Texcoco Area, Mexico
Control Point ID: Aug N5	Collection Date: 14 August 2014	Instrument: Trimble GeoExplorer
Latitude: 19° 30' 01.59" N	Longitude: 99° 02' 27.75" W	Height (MSL): 2740.841 m
Project Area: Antennas on Sierra de Tepotzotlan		Datum: WGS84/EGM96

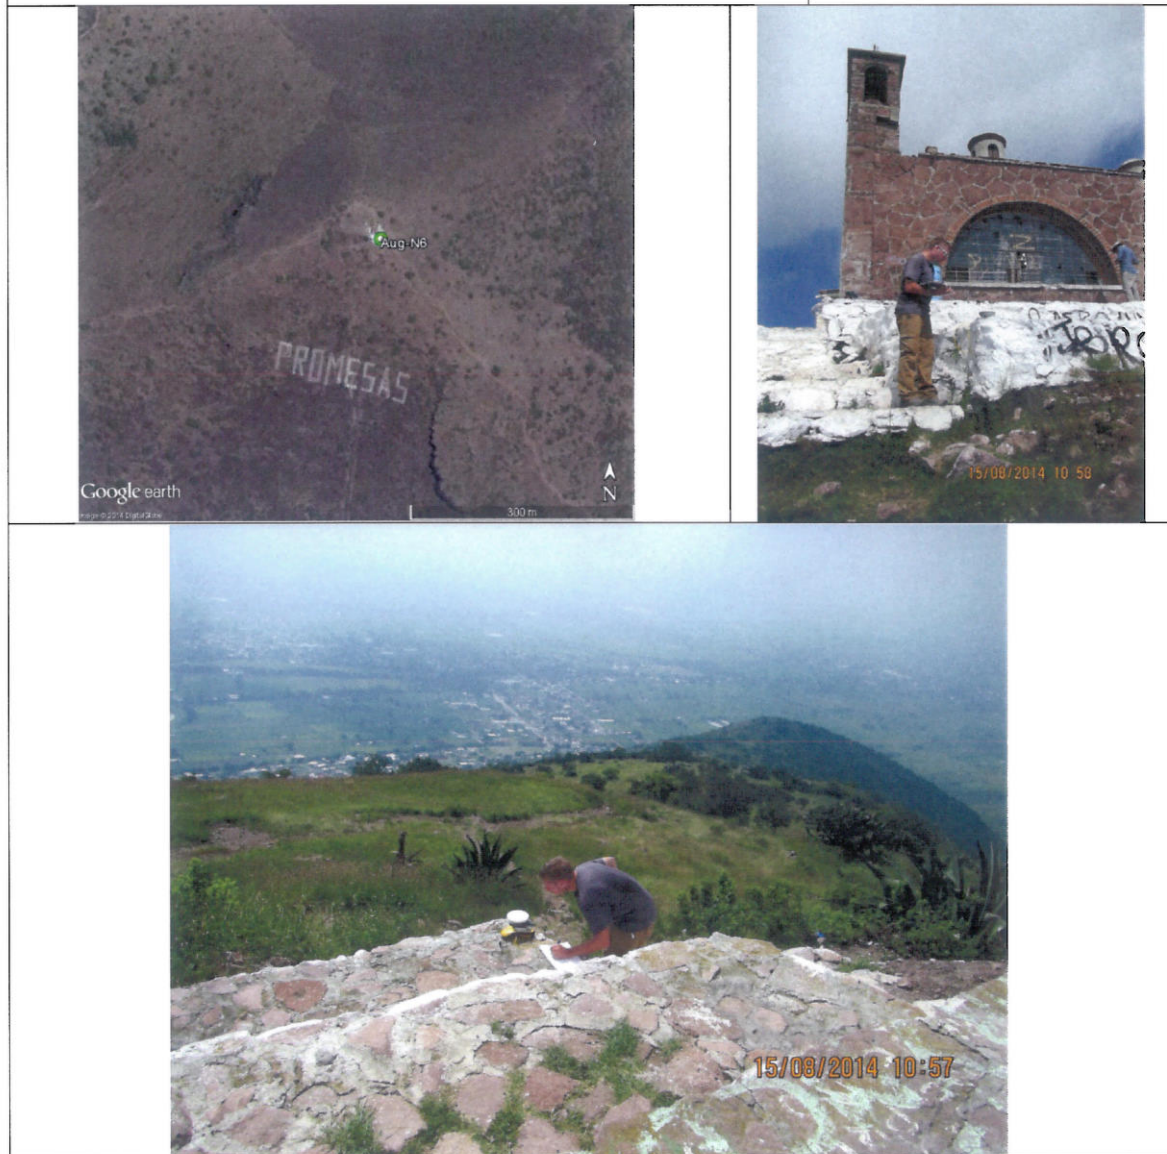
Figure A-7 – Description of CP Aug N6

Project: Texcoco Area Survey	Country: Mexico	Region: Texcoco Area, Mexico
Control Point ID: Aug N6	Collection Date: 15 August 2014	Instrument: Trimble GeoExplorer
Latitude: 19° 35' 26.15" N	Longitude: 98° 52' 07.95" W	Height (MSL): 2622.453 m
Project Area: Church at the Summit of Cerro de Las Promesas		Datum: WGS84/EGM96

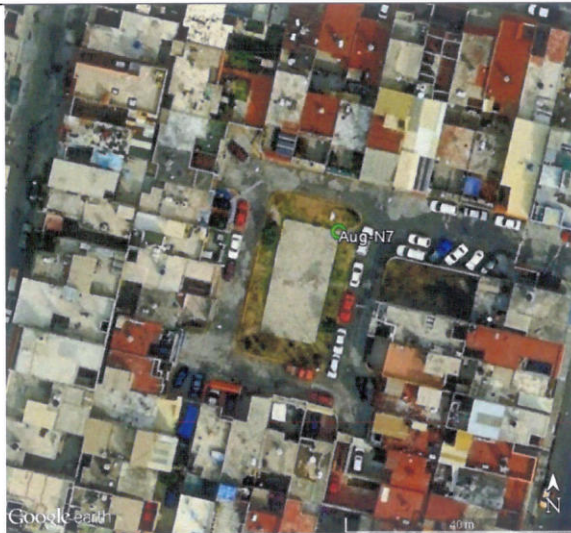
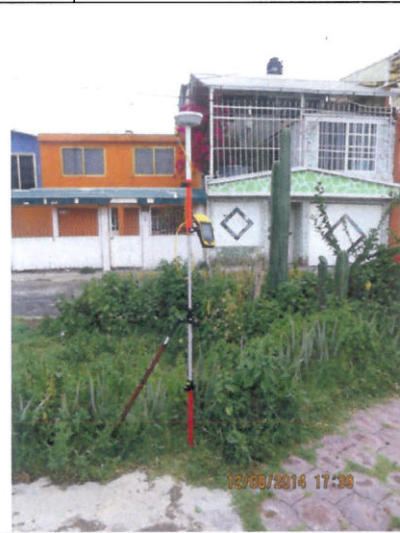
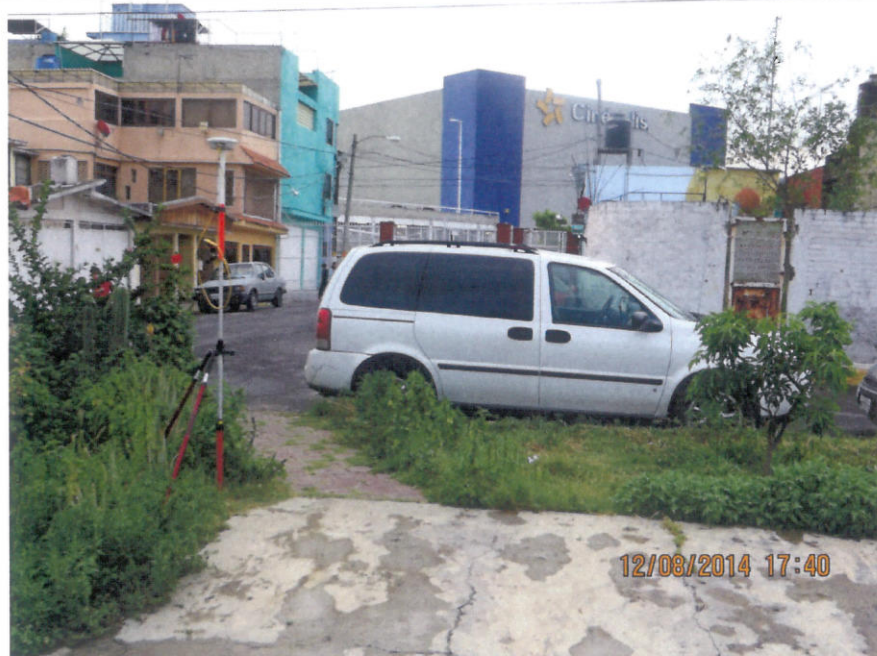
Figure A-8 – Description of CP Aug N7

Project: Texcoco Area Survey	Country: Mexico	Region: Texcoco Area, Mexico
Control Point ID: Aug N7	Collection Date: 16 August 2014	Instrument: Trimble GeoExplorer
Latitude: 19° 28' 55.01" N	Longitude: 99° 03' 14.68" W	Height (MSL): 2222.772 m
Project Area: Ciudad Nezahualcóyotl		Datum: WGS84/EGM96
