Subject: Technical Letter: Assessment of Centro de Gestión de Residuos Sólidos en el Bordo Poniente

MITRE's assessment included a determination of whether the facility would impact key instrument approach and departure procedures and International Civil Aviation Organization (ICAO) Annex 14 Obstacle Limitation Surfaces (OLS). Other important items such as One-Engine Inoperative (OEI) procedures (also known as "engine-out" operations), potential impacts from exhaust plumes, and issues pertaining to wildlife attractants were also considered.

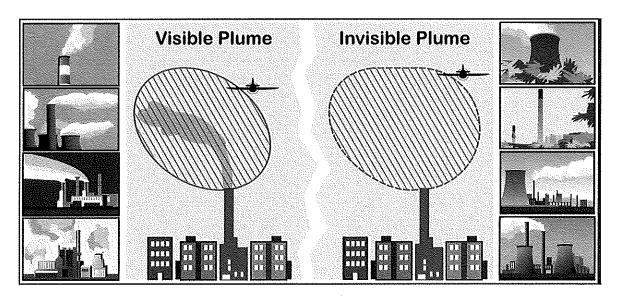
FIG 7-5-2 Plumes

a. Flight Hazards Exist Around Exhaust Plumes. Exhaust plumes are defined as visible or invisible emissions from power plants, industrial production facilities, or other industrial systems that release large amounts of vertically directed unstable gases (effluent). High temperature exhaust plumes can cause significant air disturbances such as turbulence and vertical shear. Other identified potential hazards include, but are not necessarily limited to: reduced visibility, oxygen depletion, engine particulate contamination, exposure to gaseous oxides, and/or icing. Results of encountering a plume may include airframe damage, aircraft upset, and/or engine damage/failure. These hazards are most critical during low altitude flight in calm and cold air, especially in and around approach and departure corridors or airport traffic areas.
